Very Serious Casualty

Investigation n.º 01/2019

## Investigation report / Relatório de investigação

### **Mv EF Ava, IMO 9389306 REGISTRY - GAMA 2019-012**

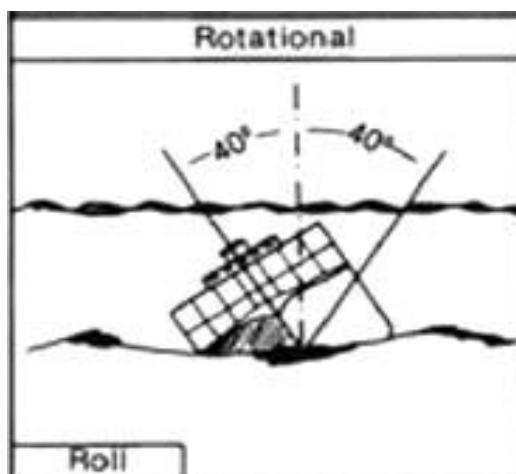
Figure 3 – Rolling acts in the transverse direction

The vessel was under heavy sea and swell, running with strong wind. The wave heights were estimated to be between six and seven meters, running just abaft the beam, causing the ship to roll heavily. At the time of the occurrence the ship was experiencing synchronous rolling, which may occur when the natural rolling period of a ship coincides with the encounter of the wave period. The solution to avoid synchronous rolling is to alter either the ship's course or speed to change the encounter wave period.

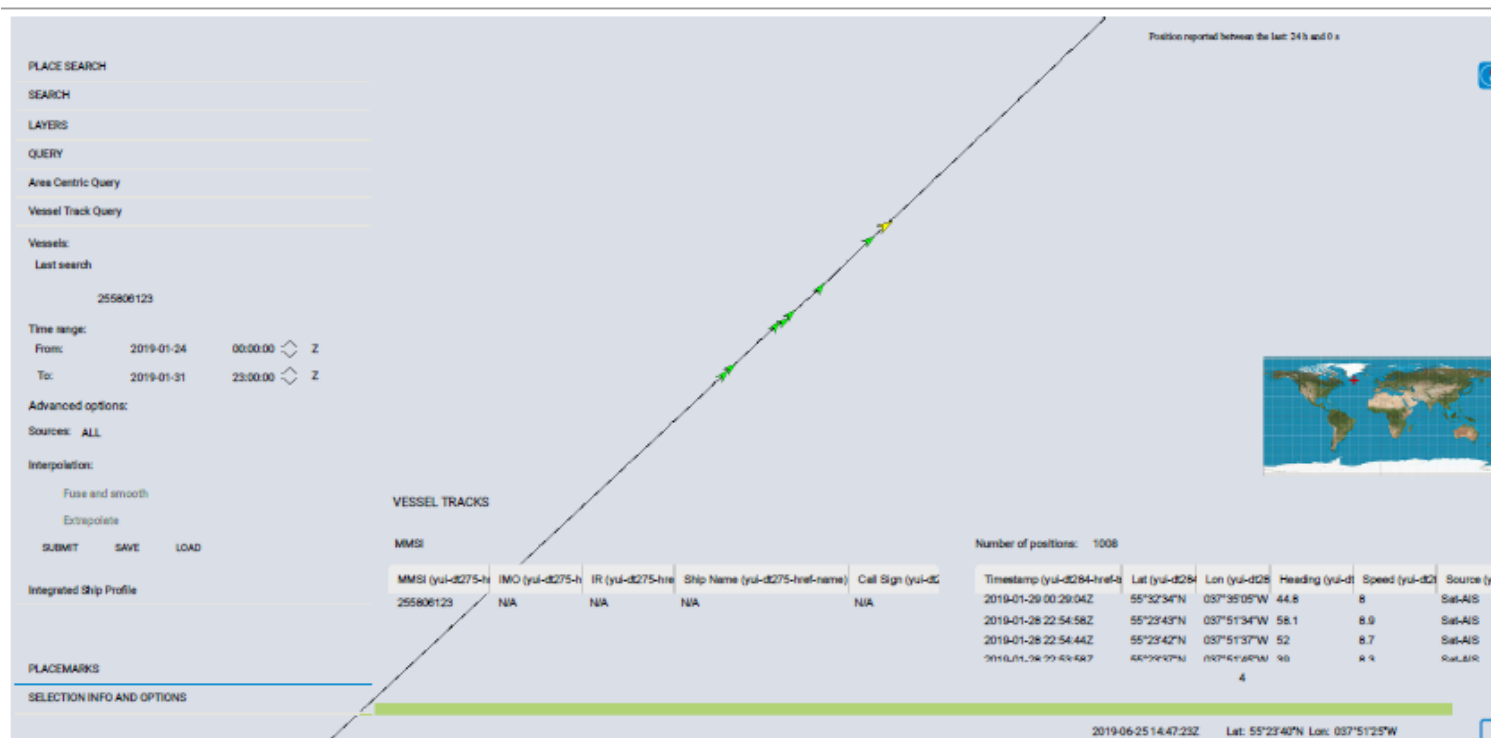
Figure 4 – Detail of the voyage record from the time of the accident

The accident occurred at 23:00 hours, the AB was standing by the steering wheel holding the safety grab rails when the ship rolled heavily, about 30° and seemingly fell into resonance – there were a series of

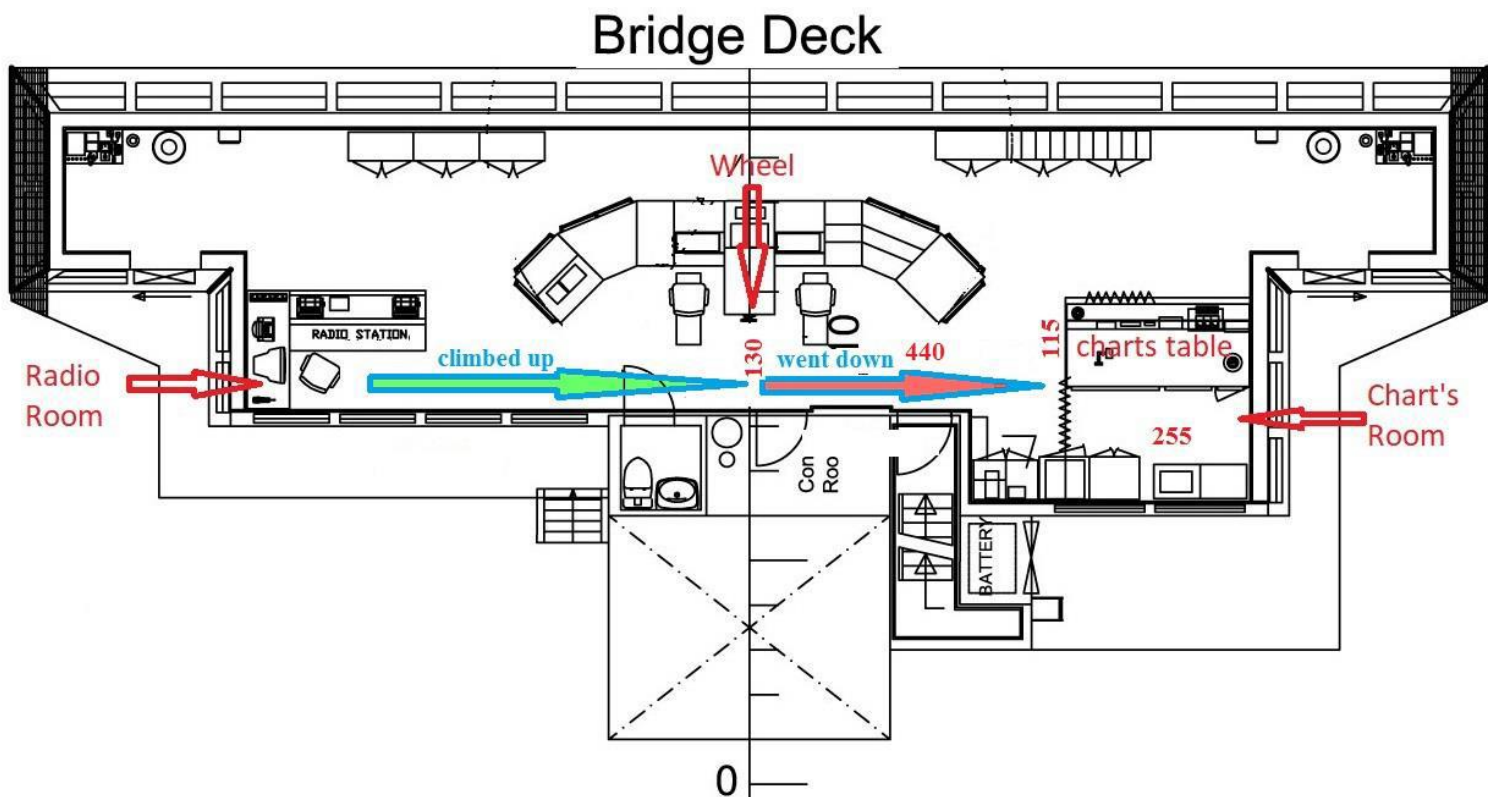
synchronous, heavy rolls. The Master interrupted his work in the radio room, located in the port side of the bridge, and whilst holding a cup of coffee in his right hand walked towards the steering position. When he started moving from the radio room the vessel was heeled to port side and the Master had to start climbing to reach the steering position. When the Master passed behind the AB, the vessel rolled to starboard and the Master started running down to starboard side rapidly and most probably lost his balance and hit his head on the corner of the chart table.

Figure 5 – Mv EF Ava bridge layout

The layout of the bridge is an important part in the sequence of events leading up to the accident. There are no safety grab rails on the bulkhead behind the centre console (figure below) but there are safety grab rails on the steering console.

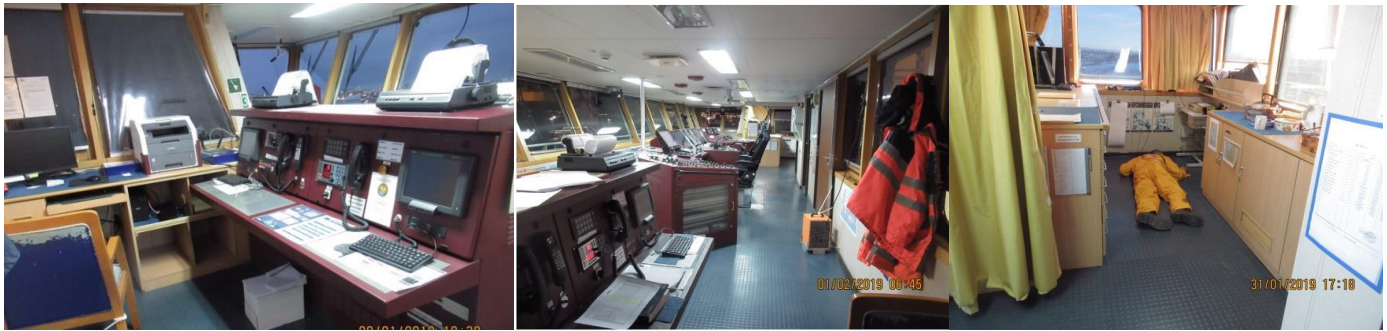
Figure 6 – Radio room, view to the chart room and simulated position of the Master in the chartroom

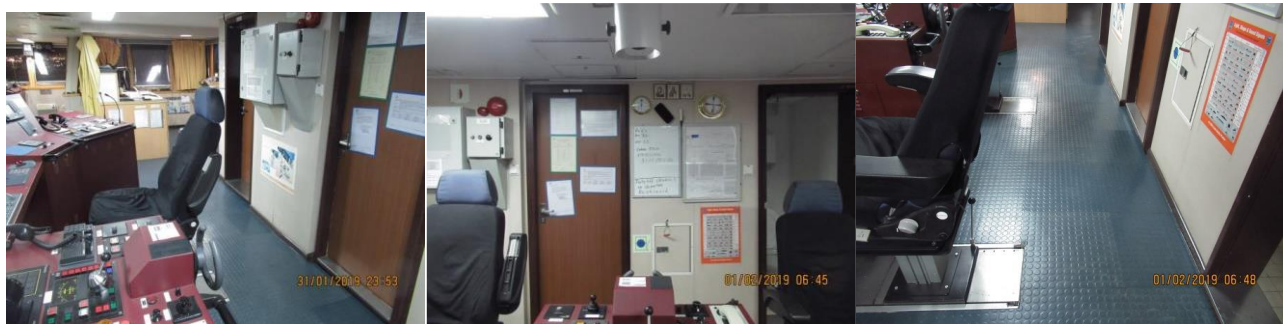
The Master was holding a cup of coffee in his right hand. He could only use the safety grab rails on his left side, and he could also grab the chair.

Figure 7 – Middle of the bridge, where the Master most probably lost his balance (No obstructions on the deck)

Following this accident, the Company issued a Circular to all vessels to be reminded of the dangers associated with synchronous and parametric rolling and decided to review and update the Working on Deck in heavy Weather Company bulletin in order to include general safety information in heavy weather.

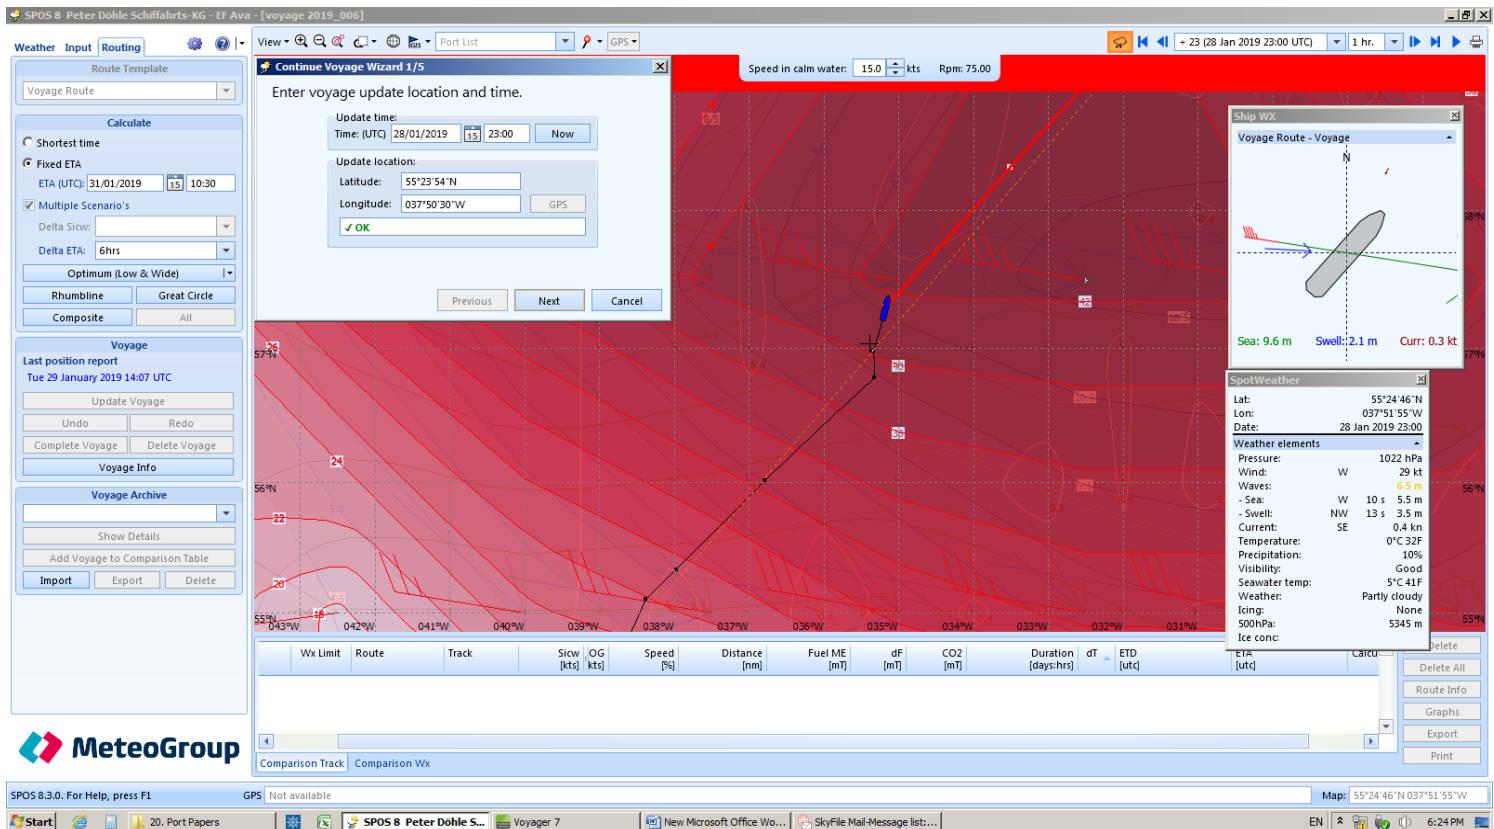
Figure 8 – Passage detail

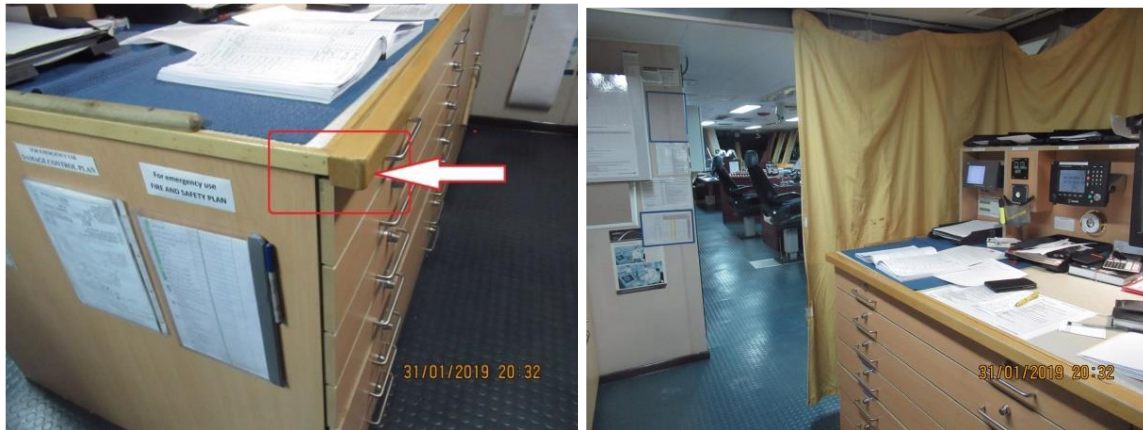
Considering the vessel was experiencing synchronous rolling, the most probably reason why the Master stood up from his chair in the radio room was that he intended to alter the ship's course.

Figure 9 – Place where the Master sustained the head injury

Standing up - after being seated for a period, holding a cup of coffee in his right hand- under severe rolling without consider the possibility of losing balance was identified as a contributing factor.
