# Investigation Report

221 - 2013

**“SAFMARINE LONGA”**

**December 24, 2013**

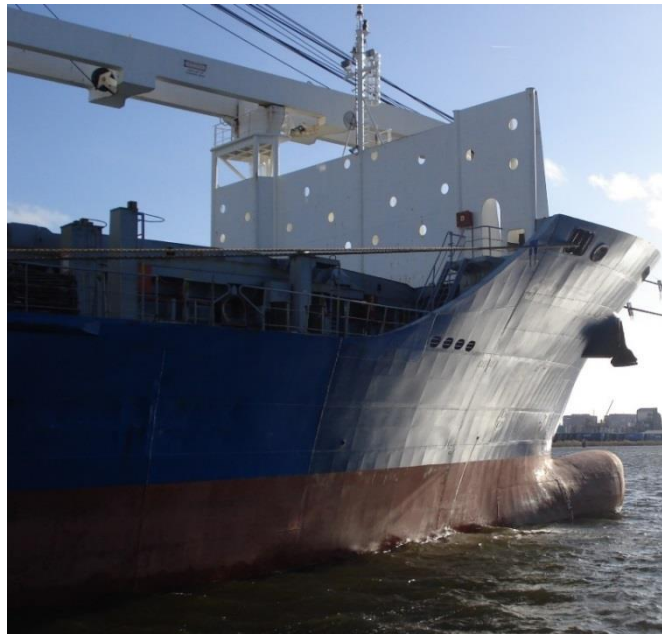
The direction of the water flow across the fore of the deck was changed due to the fact that this vessel has a great breakwater in all the bow area and this can create other flows on the bow castle. Therefore, it is not safe to claim with certainty that the wave came from PS, as this type of structure can change the direction of the water flow in 45° or more. However, the most probable cause in this case was the shock on the bow at PS.

Photo nr 1 – Photograph of the side and the bow area at SS where the breakwater can be seen.

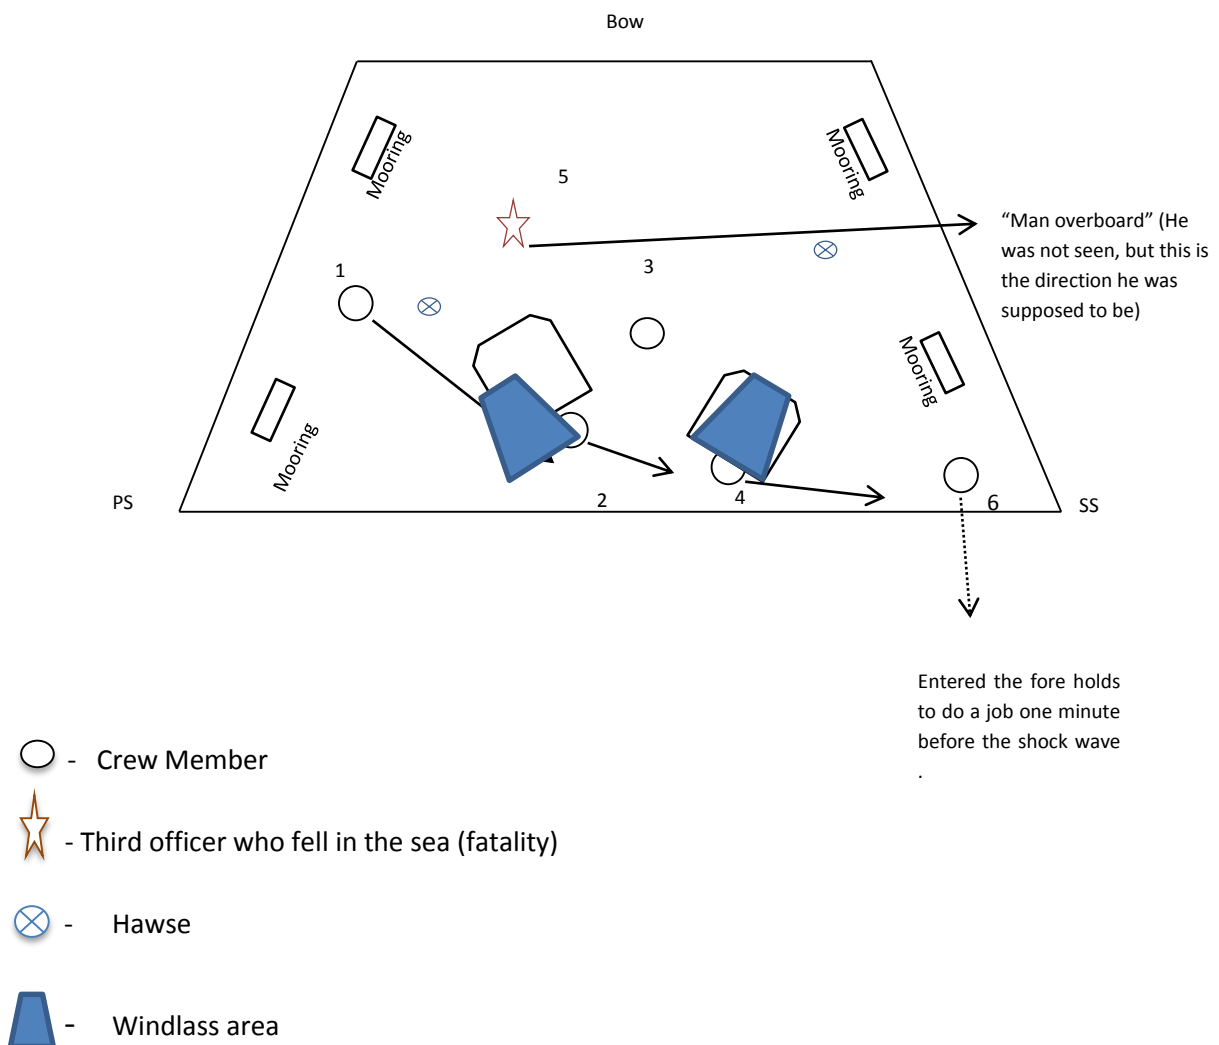
The deceased had the task of lashing the anchor at PS and, moments before the impact of the wave, would be in an area far away from the SS rail where he was thrown over (see fig. 2). As there is no other data, it is assumed that the position of the crewmembers that were operating there were the right one to accomplish the requested tasks.

Fig. 2 - Simplified diagram of the positions and movements of the crew members (after the shock wave) on the bow castle area (according to what was described by the witnesses).

The direct cause of the accident was an extraordinary high wave that hit the bow of the vessel at PS and when flooding the deck caused (due to the amount of the water) the heeling of the vessel at SS and the crew members that were working there lashing the anchors were thrown also at SS (along with the water force), including the fatality who was the only one thrown overboard, falling in the sea.

**221-2013.1** - Install restraining system device on all the fleet ships for people who are doing their tasks on the deck , especially under bad weather conditions. These systems may include harnesses or similar devices and should be part of the components list of the PPE for each member on board. After this implementation, to assure a prompt control on board of every fleet ships , in what concerns the use each member's PPS who go to work on the deck (for instance, Verification lists) , ensuring that all operations are followed under a sequential form.

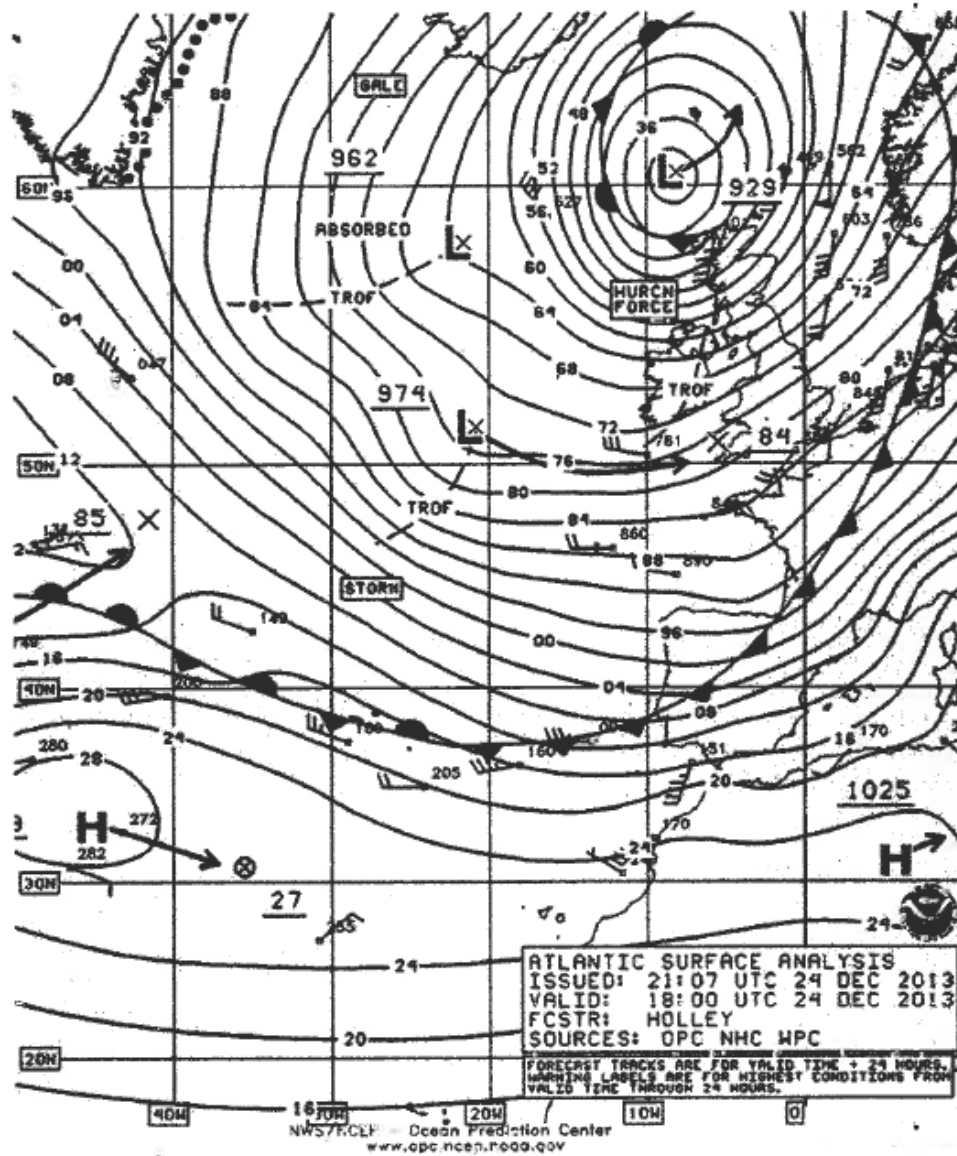
Surface analysis , issued around 2107 on the day of the accident

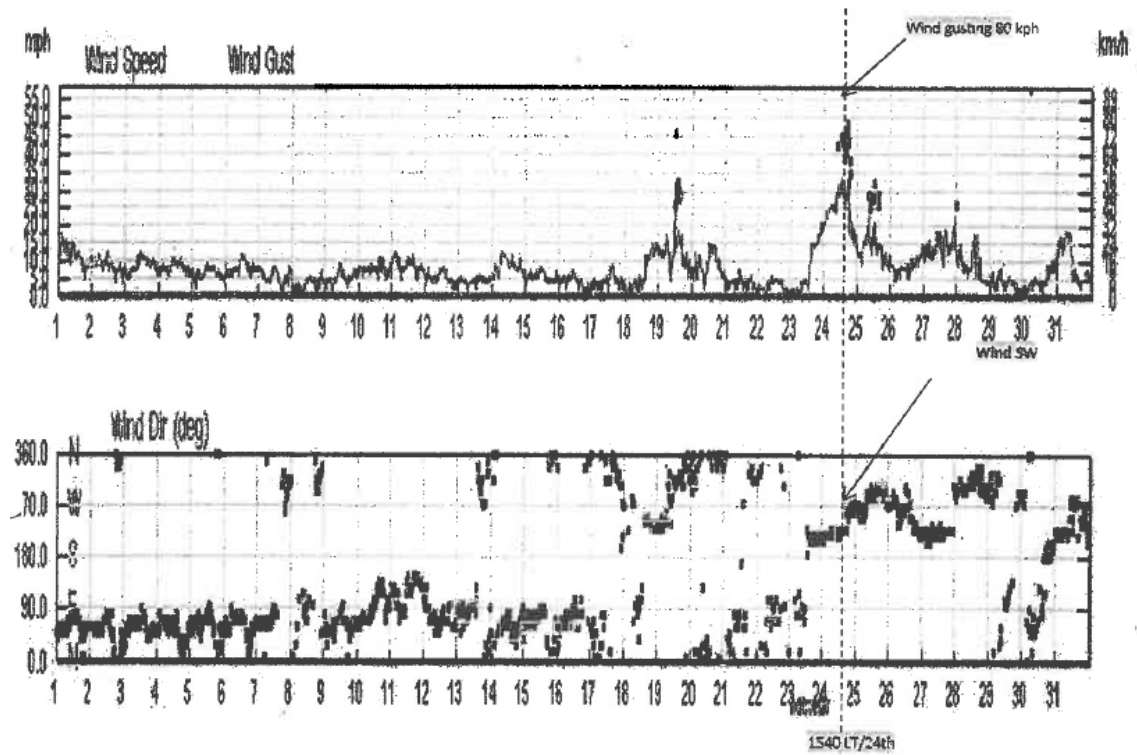
However it is also a fact that, according to the graphics of the Lisbon weather station (attachment 3) there was a wind speed peak reaching 80 km/h fast as well as a change of direction from 200<sup>0</sup> to 270<sup>0</sup> (this change of direction was not as sudden as the one that happened with the wind speed just before 1540 of the day of the accident.) Probably these wind blasts caused higher waves that hit the vessel and, consequently made the captain to worry about losing the anchors which made him order his crew to lash them, first the stern ones (which with the bow changed to 034<sup>0</sup> exposed it to the wind and the sea) then the bow ones. But under those extraordinary weather conditions, it is supposed and necessary to compensate with extraordinary measures, wherein for that moment and considering that the captain had all the weather information, it would have been more zealous to lash the anchors before leaving the Lisbon port, in order to protect his crew from serious dangers.

Speed and direction of the wind graphics on the day and time of the accident
