Gabinete de Prevenção e de
Investigação de Acidentes Marítimos

Investigation Report 54 - 2013

“Douro Queen”

Report nº: 54/2013

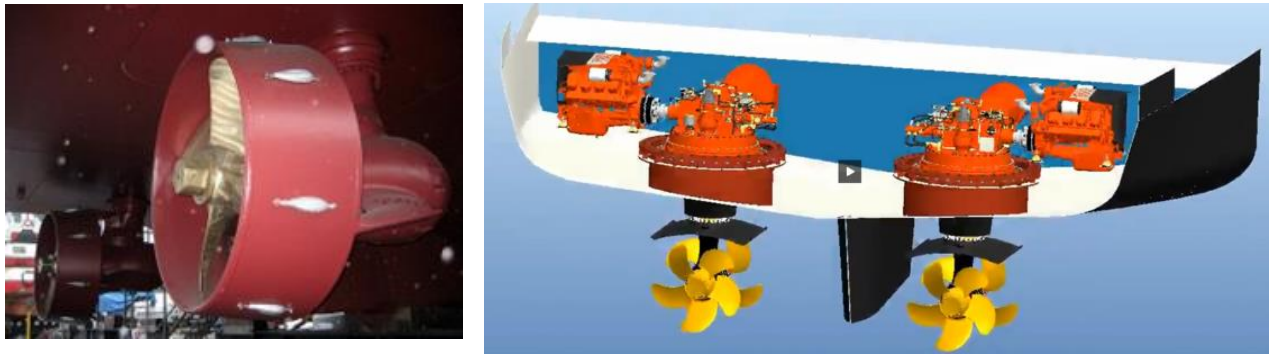
Fig 1 – Type of steering and maneuver “Veth Z Drive”

The master, following the instructions of the steering system manufacturer (“Veth Z Drive” – Fig. 1), tries to restart the system. However he could not do it.

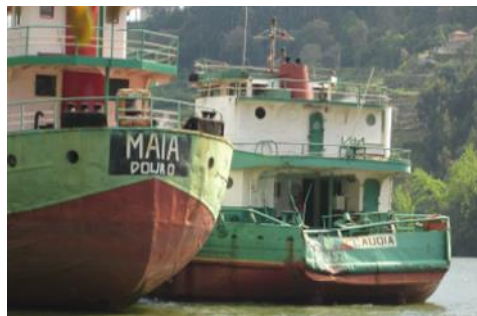
Fig. 2 – Damage on “Cláudia” and on “Maia”

Due to the reduced width of the river in the area, the available space to immobilize the ship is not enough, consequently the “Douro Queen” crashed into the stern of two vessels “Cláudia” and “Maia” that were moored side by side on the north margin of the river, at a local pier, which caused the braking of the mooring of the vessels. The vessel “Cláudia” was moored on the outside of “Maia”.

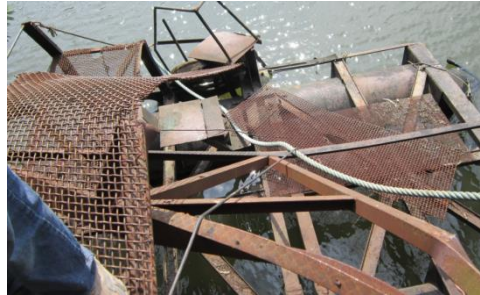
Fig. 3 – Damage on the bridge

The collision still caused some damage to the bridge (fig. 3).

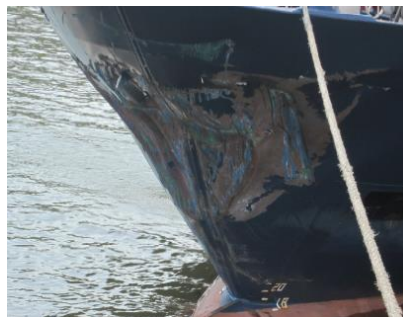
Fig. 4 – Damage on “Douro Queen”

After this maneuver and having received instructions from the owner whom he had contacted via cellphone, the master sailed “Douro Queen” to the Inersel – Construções, S.A pier that was near them, in order to proceed to the disembark of and assistance to the passengers that were on board and to proceed to the assessment of damages, surveys and repairs that would become necessary.

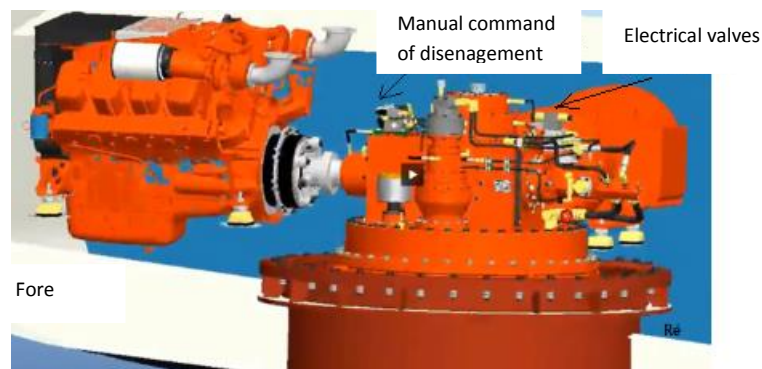
Fig. 8 – Manual commands of the propeller

To operate the alternative steering of the vessel (direction) it is necessary to operate the electric valves situated at the stern of the propellant head “Z-Drive” (fig. 8).

- e) The difficult access available to the alternative manual commands to both propellants and their distribution in a way that did not allow their operation from a single point in the machine house;

54-2013.4 To install in ships with one or more propellants “Z-Drive” type, especially in the ones intended to sail in restricted areas (rivers) and/or with narrow machine houses a control and a manual system close to the propellants and reserved to a single point of the machine house so that only one operator may intervene in all propellants simultaneously without having to “run” from one place to another in the machine house, either to disengage them or to work on the command electrical valves using improvised tools.

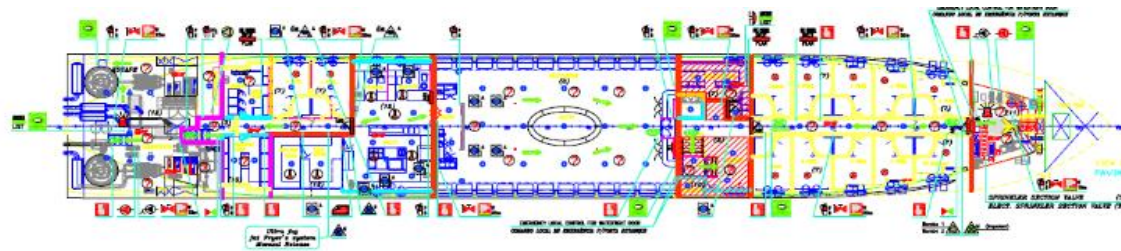
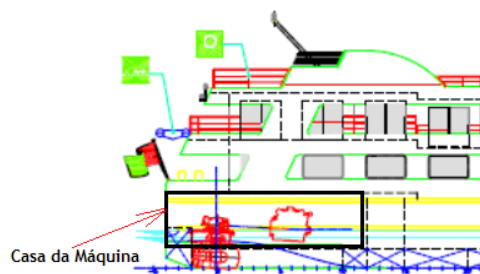
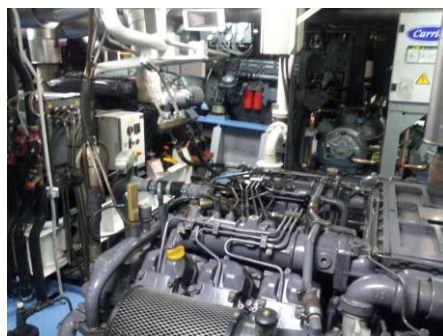
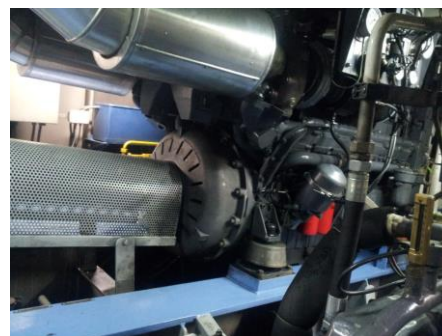
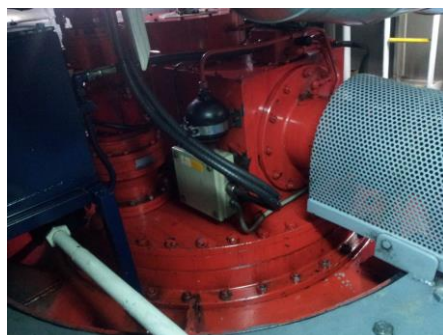
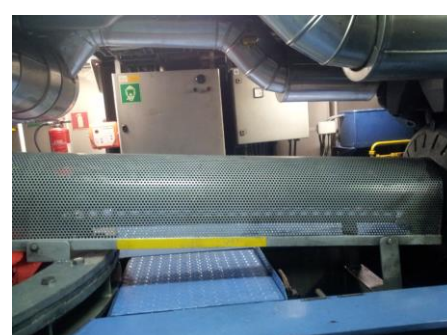
Fig.9 - Machine house covering plant of "Douro Queen", details of its arrangement and inside views

The Machine House (MH) of “Douro Queen” is located at the stern, with an entry through the maneuver park of the stern and, as it can be seen on Fig 9, it is quite small, thus there is little free space between the several items installed there. The access to the stern part of the “Z-drive” propellers is quite difficult and the available space is quite small which makes the position to operate the electrical valves of the propellers controls quite uncomfortable and requires the operator to be in a squatted position, even a bit twisted.

When the MH is fully operating, i.e. in a normal mode with the two generators and both main machines operating, the noise level inside is very high which makes communication very difficult.

Afterwards, in case he did not have the right screwdriver nearby to operate on the electrical valves, he would have to go to the warehouse, grab it and go to the opposite side so that he could go around the “Z-drive” propellant’s head where he would work, in order to get a position at its stern. For this, he would have to squat to pass over the engine shaft connected to that propeller, go close to the rail, place himself sideways and go behind the propellant’s head, squatting near the electrical valve.

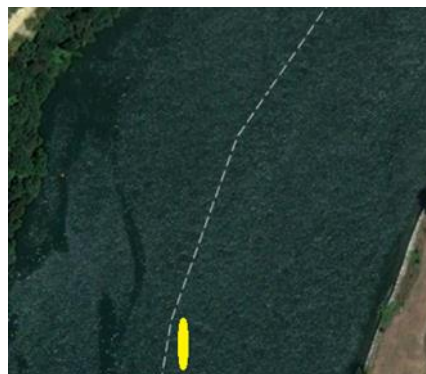
Fig. 12 – Canal axis and position related to “Douro Queen” (modified image. Source: Google Earth ®)

Considering that the traffic, at this particular section, was little and as a safety manner to prevent eventual changes on the depth occurred on the river bed due to the heavy rains and frequent discharges done on the previous days by the dams upstream of the river, the master decided to sail close to the canal axis, slightly close to starboard (Fig.12).

The distance between the canal axis to the north river banks was about 110 meters at the narrowest section, widening to about 160/180 meters at the widest section. I.e., the length of the ship corresponded to, approximately between 70% from the available distance to immobilize the vessel in the first case and about 50% in the second case.

54-2013.1 To implement a transit timetable procedure on his ships that ensure a safety speed maintenance in all inland water ways of the river Douro, wherein the safety speed means “the one that allows to stop the ship in an appropriate distance to the existing circumstances and conditions”.
