INVESTIGATION REPORT

94 - 2013

**“POR DEUS
AJUDADO”**

Report nr. : 094/2013

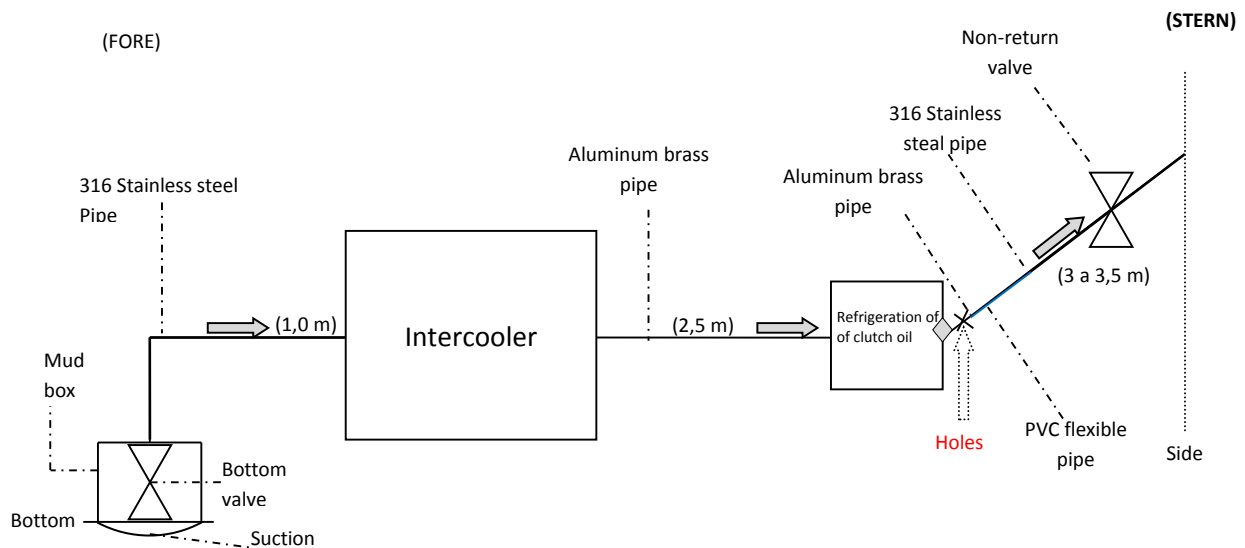
As above mentioned, the holes appeared on the same type of aluminized brass where a previous welding had already been done – see fig. 1, because a hole had already appeared there. The previous cause had been corrosion.

Fig. 1 – Simplified diagram of the cooling system of the vessel and where the pipe corrosion took place (see fig. 11 of the manufacturer general diagram).

The damaged piping was detected behind de engine, at the clutch cooling oil outlet, where the corrosion breaking points can be seen (holes) – see fig. 1

After repair , the investigation team noted that the pipes were reviewed and those made of aluminum brass were replaced by stainless-steel 316 of 48mm diameter and 3,2 mm thick, which gives a greater safety in terms of protection from corrosion, having in consideration the pressures, salinity and other features of the cooling system of this vessel.

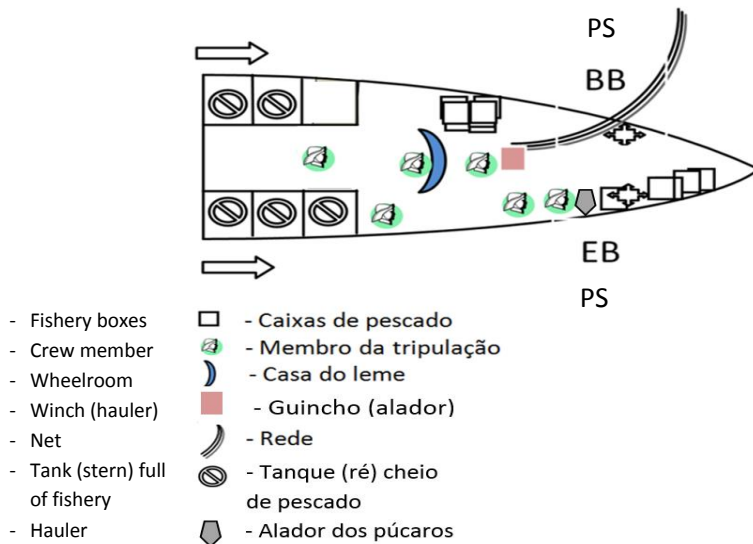
So, at starboard side, the vessel had a concentrated weight equivalent to 1% of the total displacement (cargo + crew): 0,21 ton of fishery (7 boxes) + 0,18 ton of crew (3) = 0,39 ton.

Therefore, the total weight on deck, plus the stability evidence conditions, would be: 0,39 ton of fishery (13 boxes) + 0.48 ton of crew (6) = 0,87 ton, i.e. approx. 3% of total displacement.

The bulk (cargo + equipment + crew) were spread, as shown in fig. 2, which *per se* is not in accordance with the metacentric height, i.e., the location of the points to define the balance of a floating device (see fig. 3), considering that it would be approximately only 3% of its total displacement. It should be noted that the displacement at the moment of the accident would have been approximately 33, 51 ton, which corresponded to about half cargo.

Fig. 2 – Vessel diagram representing the several fishing equipment, the crew members' position, the fishery boxes and the stern tanks.

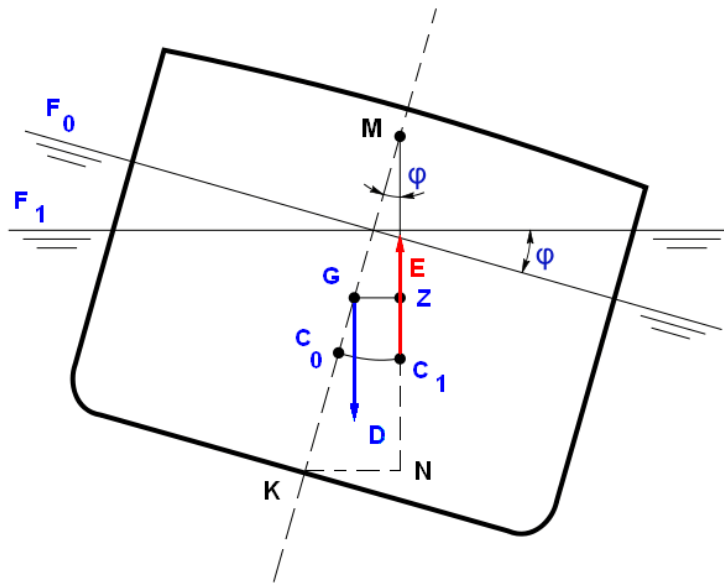
Therefore, if the engine room was flooded with water coming from the damaged pipe up to the top level of the fuel tank on the foreside, the flooding would cause a metacentric height (GM) minimum reduction of 0,03 m. The effect of the water mirror phenomena in the engine room would contribute even more to this reduction. On the other hand, if the flooding would exceeded the top of the foreside tanks, then there would be a minimum reduction of 0,05 m GM. For information only, it should be noted that, in order to ensure a stable balance, the gravity center (G) must be on the vertical center of the displaced water or the *Carena* Centre (CC) [**body of the vessel below waterline**] and from a distance upwards not too much high to ensure a stable balance (see fig.3)

Fig. 3 – Metacentric height, defined by segment GM. The vessel became unstable when segment KM (variant that depends on the relative positions of G and C ($C_1; C_0$) and the stability branch, which, on the other hand, depends on each vessel cargo condition, i.e., the condition of a cargo at a considered point in time) was minor to the segment KG (gravity center ordinate). G – Gravity center; C_0 – Gravity center of the displaced water; M- Transversal metacenter; Φ - Inclination angle; GZ – Stability branch; ME – Straightening moment.

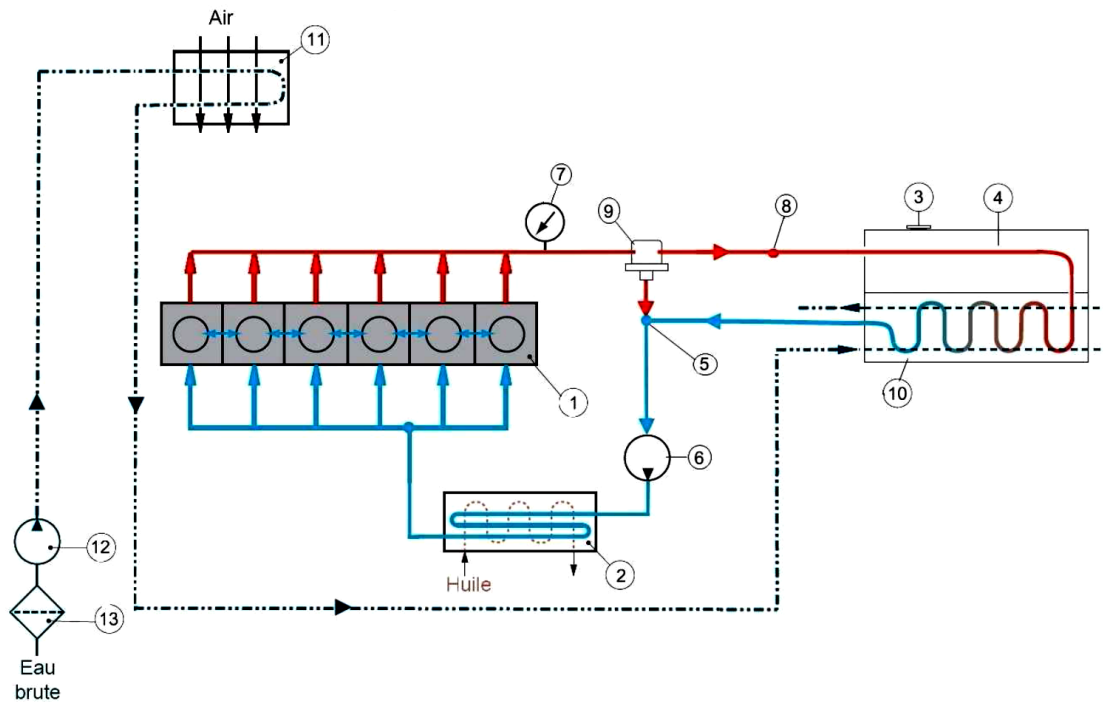
As far as the vessel cooling system is concern, the main engine (model 6W126) is equipped with two cooling circuits see fig. 11;

Fig. 11 – General diagram adapted from the operation principle of the engine cooling system of the vessel “POR DEUS AJUDADO” (open and closed). 1 – Block and head of the cylinder; 2 – Engine oil cooler; 3 – Pressurized cover of the fresh water container; 4 – Expansion tank; 5 – Return central heat circuit; 6 – Water pump; 7 – Fresh water temperature sensor; 8 – Central heat feeding circuit; 9 – Thermostat Valve; 10 – Fresh/sea water heat exchanger; 11 – Supercharged air heat cooler; 12 – Sea water pump; 13 – Sea water filter; 14 – Clutch oil cooler . Source: *Moteurs Baudouin*.

In an open circuit, the cold sea water may cause thermal stress, mainly in the pipeline, that is why the corrosion there is inevitable high.

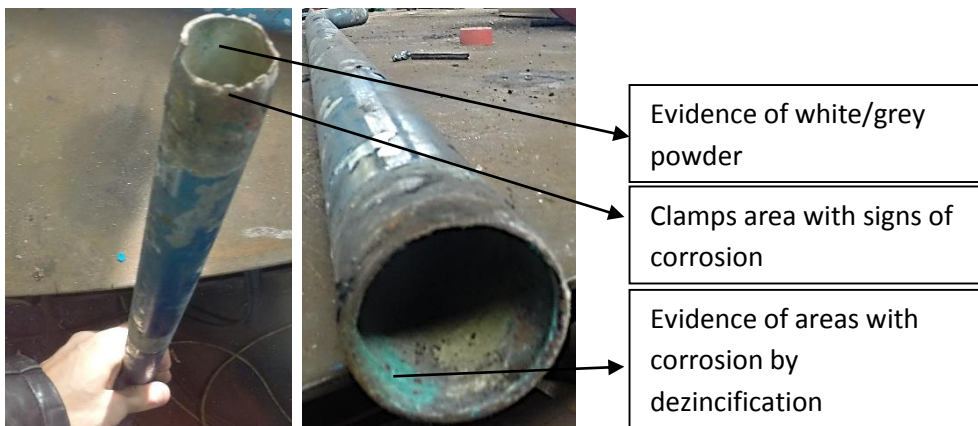
The pipes that were installed at the time of the accident showed signs of visible corrosion, it was noted empirically that on these pipes (that were installed on the vessel in 2012) the corrosion was more visible at the tie-ins, clamps and curves areas, which indicates a gap corrosion through a differential ion concentration action, cavitation phenomena and turbulence.

Photos 1 (left) and 2 (right) – Cooling system of the vessel “POR DEUS AJUDADO” oxidation on the aluminium brass. The white/grey (photo 1) and green (photo 2) areas indicates evidence of corrosion products.

However, the corrosive process that occurs on zinc alloys used on cooling systems as the one on “POR DEUS AJUDADO” is called corrosion by dezincification where the anode materials in this case is zinc, remaining the copper and the consequent corrosion products (see photo 2). This corrosion is more evident in brasses with high zinc content like aluminium brass (76% Cu, 22% Zn and 2% Al) and yellow brass (67% Cu and 33% Zn), but can be seen even on more resistant alloys like red brass (85% Cu and 15% Zn).

- 094-2013.4** - A recommendation should be issued immediately to all their clients who use similar engine cooling systems on their vessels, in order to replace all the aluminium brass; yellow; red and/or cupronickel pipes by more corrosion resistant pipes submitted on this technical report (for example, Stainless-steel 316).
- 094-2013.5** - If that is not available, and after the implementation of the Safety Recommendation# 094-2013.4, it should be sent to all operators/shipowners/builders/shipyards who operate or intervene in vessels with open cooling systems (only open systems or combined simultaneously with closed systems) installed by Sociedade Vítor, Lda and/or by Baudouin, preventive maintenance manuals and refitting of those systems where the welding procedure should also be included.
