Gabinete de Prevenção e de
Investigação de Acidentes Marítimos

Investigation Report 54 - 2013

“Douro Queen”

Report nº: 54/2013

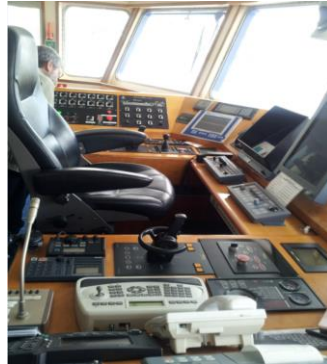
Fig. 5 – Command and steering console on the bridge

The ship “Douro Queen” has an azimuthal propelling system consisting of two machines equipped with “Veth Z Drive” directional propellers, one at SS and another one at PS that can work either independently or in pair mode, i.e., their speed or direction can be operated independently of one another or can be controlled simultaneously by a unique command wherein one of the machines works on a “slave” mode from the other.

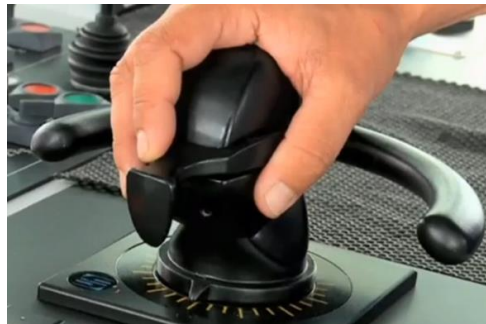
Fig. 6 – Steering and maneuvering command of each of the propellers

The independent function way is normally chosen when the ship starts the maneuvers and the pair-mode is used during transit along the river because the independent control of each propellers in addition to be very tiring when exposed to a long operation period, may be a risk in this type of navigation, i.e., may not keep the desirable stability, both for deflections as for straight direction sailing.

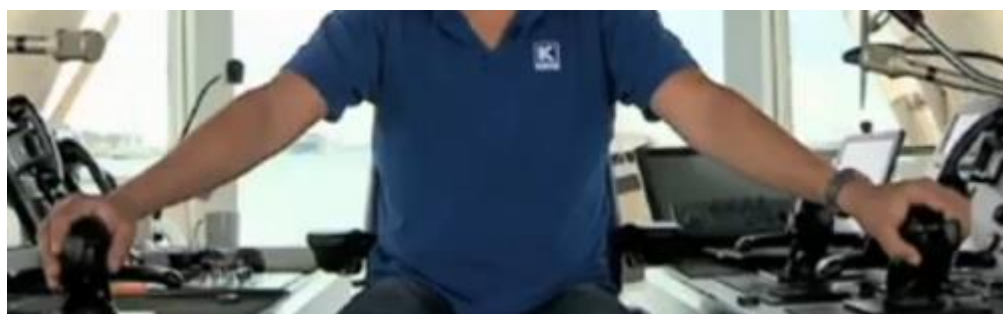
Fig. 7 – Operator's position during independent function mode

It should be noted that the manual operation of the two propellers must be done under independent functioning, i.e., it is not possible to operate them in a *master/slave* mode and to be able to operate the two propellers in a manual mode simultaneously it is required two operators (one for each propeller).

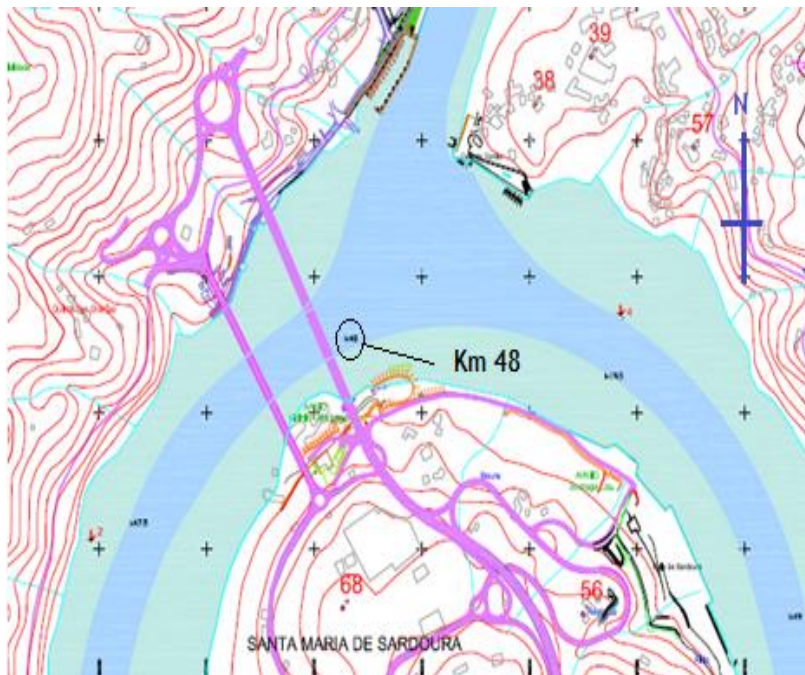
Fig. 10 – Excerpt of chart nr 24 of the inland waterway of river Douro (DGRM)

Upstream and after passing Sardoura dock, the river bends to the right at the Entre-os-Rios area (Fig. 10), therefore the ships have to do a sharp turn to starboard.

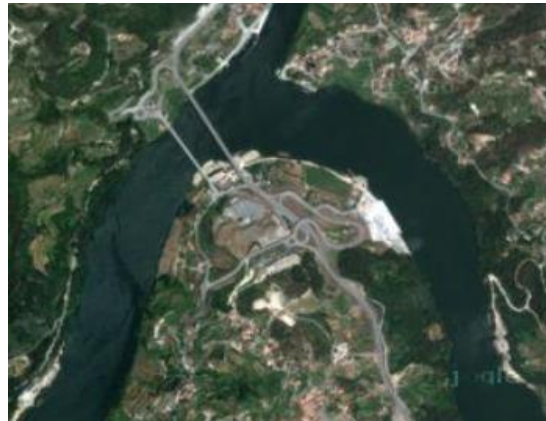
Fig. 11 – Satellite view of the curve of the river (Google Earth ®)

In this area and in the middle of the canal, the medium depth of the river is 12 meters, the minimum width is 200m and the maximum is 320m and the available distance from the center of the canal to the north bank varies between a minimum of 100 to a maximum of 160/180m.
